INSPECTION CERTIFICATE

Report No. 090711A

Order No. (Conf. No.)	2009-123				
Description:	XXXX 25"x 9"XX LED open sign				
Lot Quantity:	3,000pcs				
Sample Quantity:	125pcs				
AQL Level(MIL-STD 105D,IIA)					
. Critical Deficiency		Accept	0pc	Reject	1pc
. Major Deficiency	1.0	Accept	3pcs	Reject	4pcs
. Minor Deficiency	4.0	Accept	10pcs	Reject	11pcs

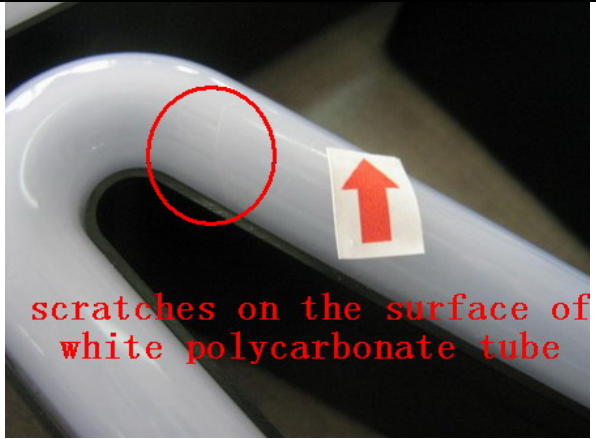
Deficiency Observed	Critical	Major	Minor	Remarks
1) Appearance	0	0	3	3 x scratches on the surface of white polycarbonate tube
2) Material	0	0	3	3 x injection mold marks
3) Function	2	3	0	2 x malfunction of the printed circuit board, with hazardous concern; 3 x loose assembly of white polycarbonate tube on ABS plastic board.
4) Packing	0	0	0	
5) Shipping Mark	0	0	0	
6) Documentation	0	0	0	
7) Others	0	0	0	
TOTAL	2	3	6

Defective

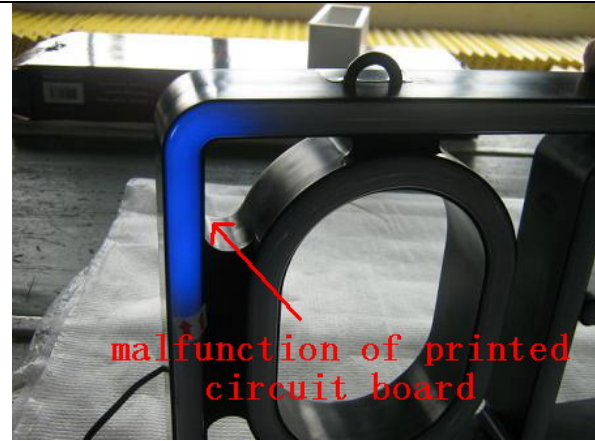
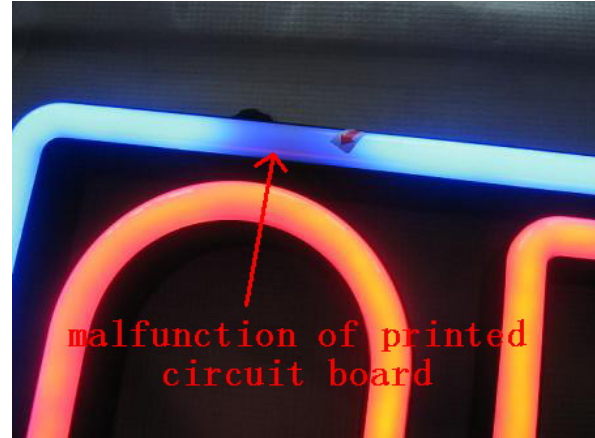
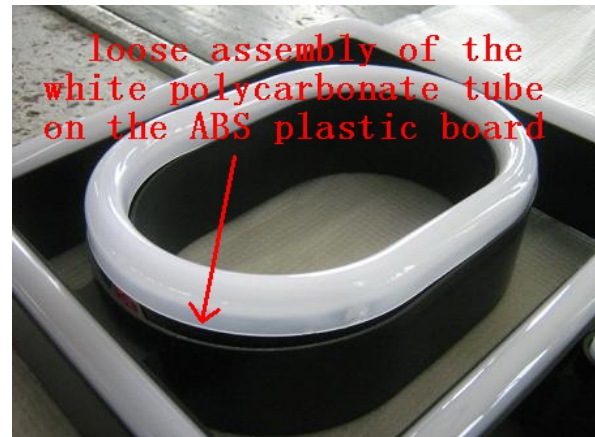
Defective

1. **Malfunction of the Printed Circuit Board:** 2pcs with the "critical" defect among the 125pcs checked. The LED light was still on after the power is shut down, it was obviously with a short circuit situation on printed circuit board. Since there is a hazardous concern so we define it as a "critical" defect. According to standard, shipment has to be rejected with any "critical" defect.
2. **Loose assembly of white polycarbonate tube on ABS plastic board:** 3pcs with the major defect among 125pcs checked.
3. **Minor defects like injection mold marks (3pcs) and scratches on the white polycarbonate tube (3pcs)** were found among 125pcs we checked.

1. We strongly doubt that there is design or manufacturing problem on printed circuit board. THIS IS A CRITICAL PROBLEM. Factory has to review both design and manufacturing process and find out actual reason before reworking the production.
2. Factory need to review and fix assembly process so not to repeat loose assembly problem.
